SMK

CONSULTANTS

Report on the effect of construction of mounds for dwellings on flood level and pondage at Proposed Subdivision of 9 Sunnyside Road Moree.

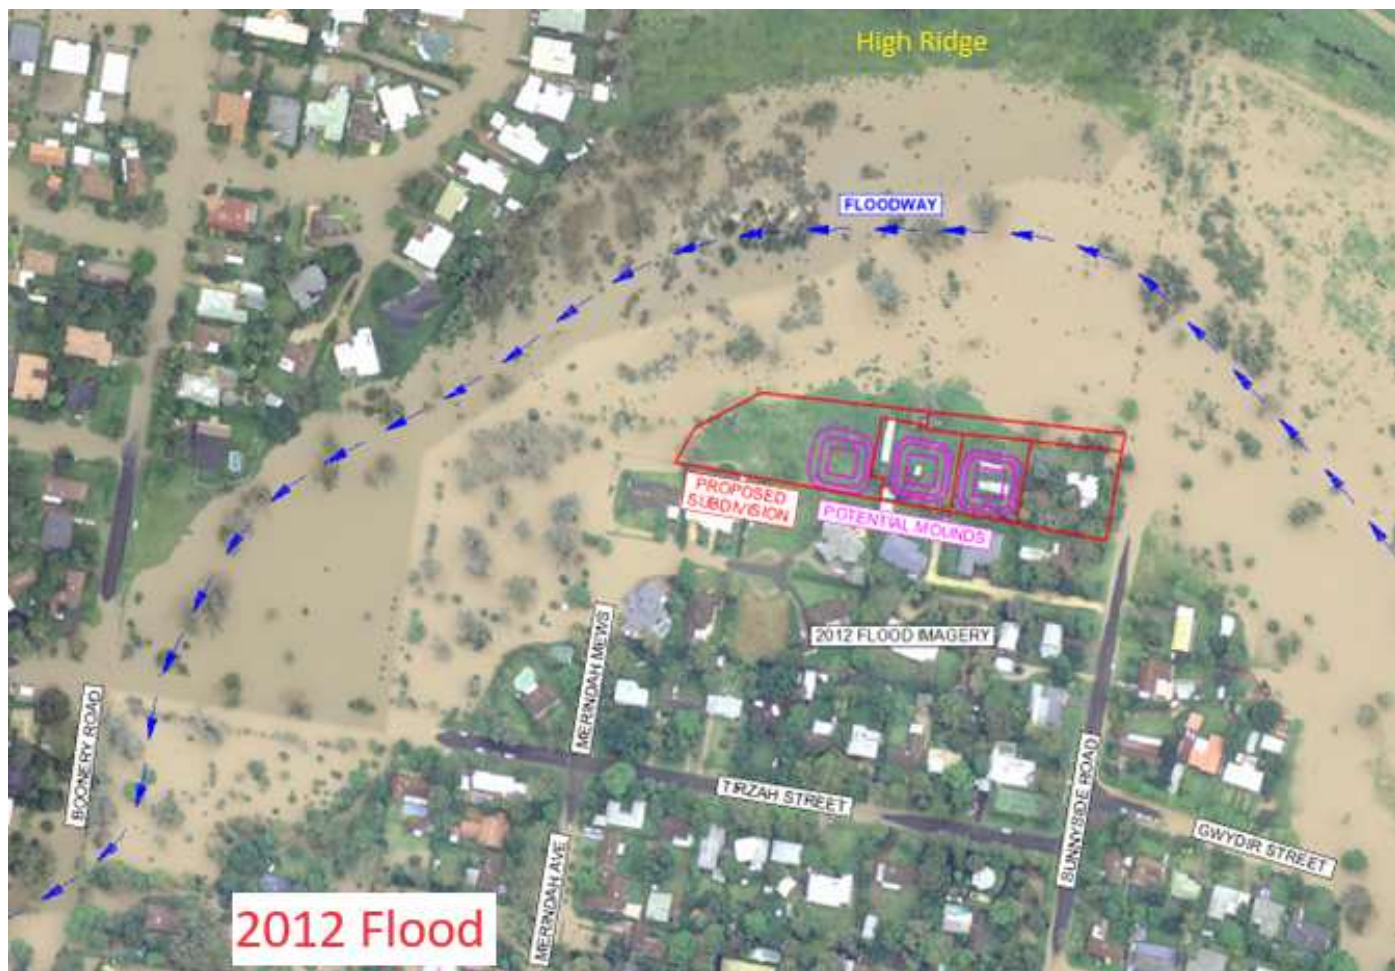
- There is a high ridge between the Gwydir Street flow path and the flow on the northern side of the Sewerage Treatment Works on the western side of the treatment works.

- The floodway on the northern side of the subject lots is generally referred to the Boonery Road Floodway.
- The Boonery Street Floodway is only connected to the floodway on the northern side of the Sewerage treatment Works in extreme flood events. During the 2011, 2012 and 2022 floods being the highest recent floods within Moree, the northern and Boonery Road floodways did not join.

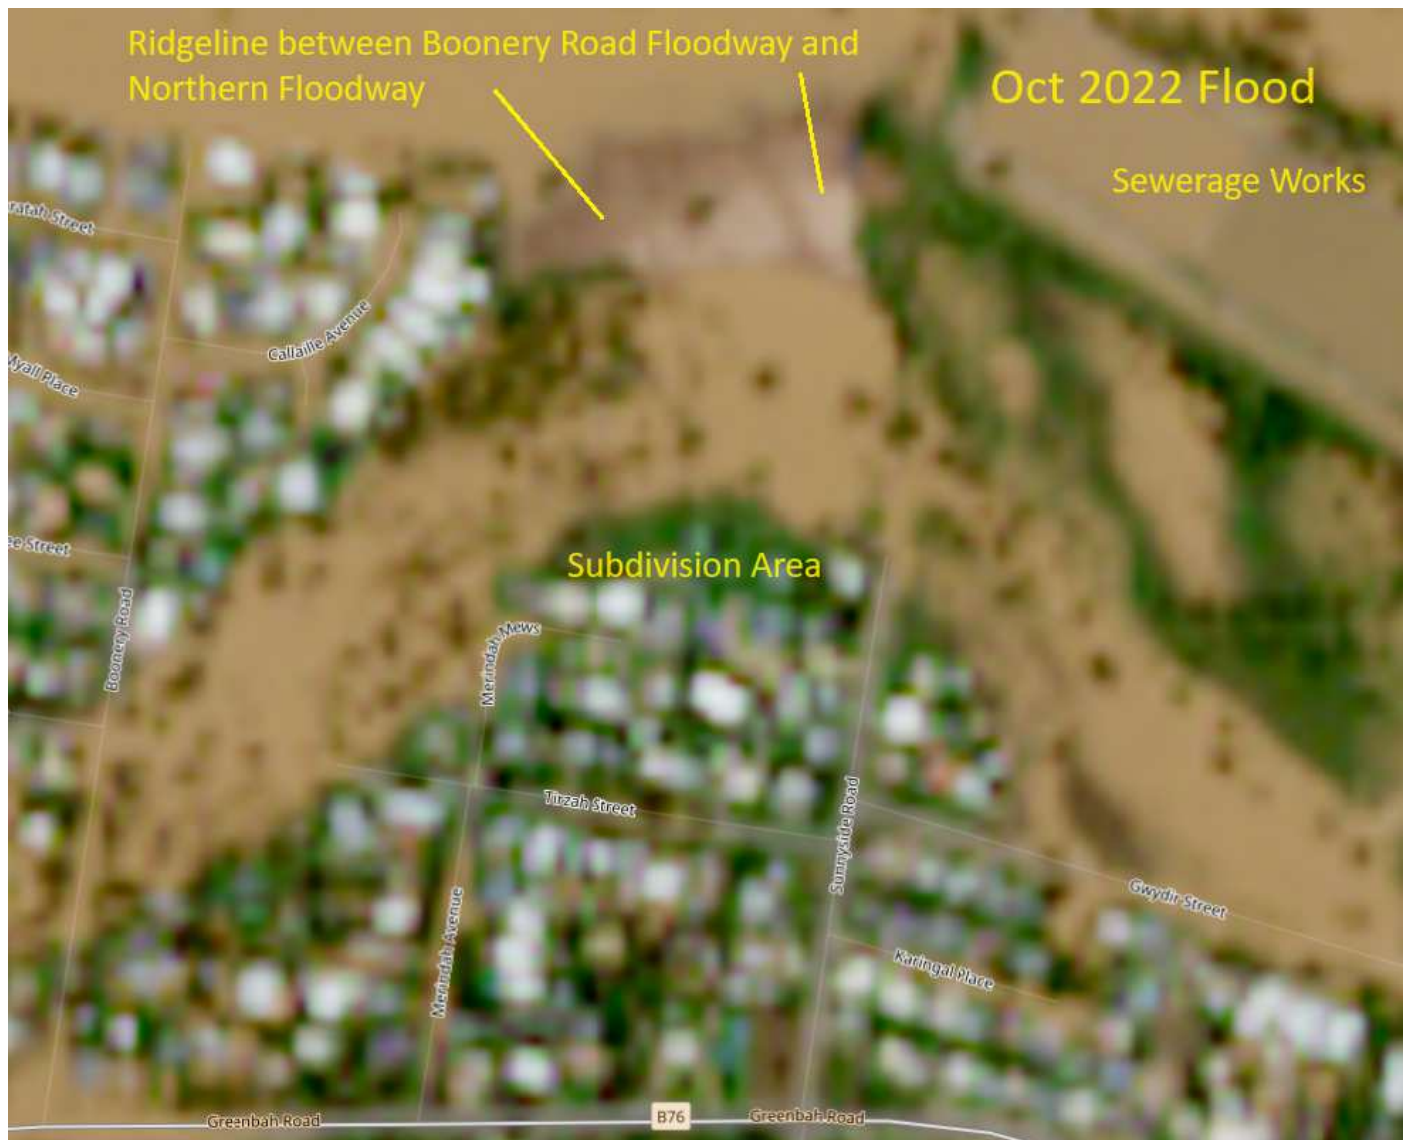
Also, the image below shows the 2022 flood would not be affected by the proposed house mounds.

Also, the ridgeline between the Boonery Road floodway path and the floodway on the northern side of the sewerage works is higher than the flood level.

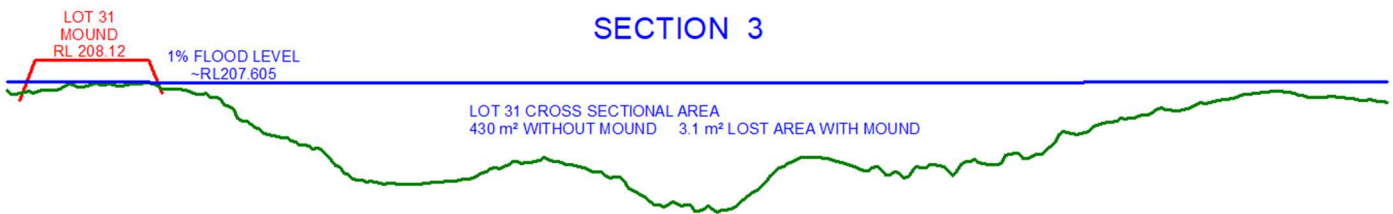
The following cross section shows the natural surface levels of Cross Section 1, 2 and 3. The proposed Mound location and height and the 1%AEP flood level.

Section	Original Section Width	Reduced Width	Storage Area	Storage Area Reduction	Increase in flood depth
	m	m	sqm	sqm	m
1	285	250	491	13	0.052
2	279	267	404	2.4	0.009
3	316	281	430	3.1	0.01

The previous images of each of the sections shows at Sections 2 and 3 the area of floodwater displaced is minute compared to the total flow area for each section. Visual inspection of the cross sections shows the mounds will have little to no effect on adjacent lands. The increased water level of 9 and 10 mm will not affect the houses to the south nor the houses on the northern side of the floodway. The northern floodway will assist in reducing these minute increases and further reduce the effect of the mounds. Regardless the increased water levels are considered negligible.

At Section 1 the mound will cause a 53mm increase in flood level which again will not affect the land to the south and will partly be distributed into the northern floodway and therefore reducing its effect on downstream residences.
